# RESEARCH REPORT AND SOLUTION PROPOSAL TO THE **MIDSTREAM MAHIGA RIVER**

## **PART A: Research Paper**

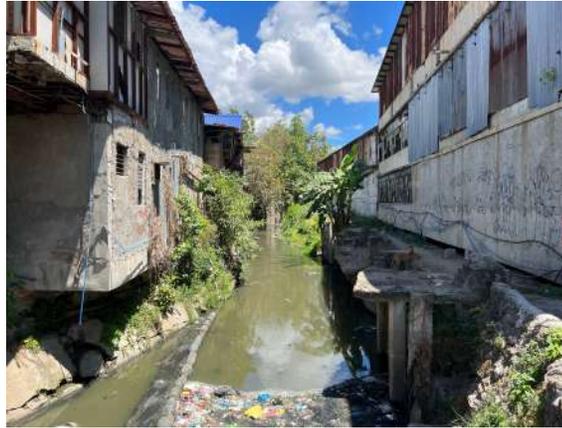
**Figure 1.2.** *Water condition of Mahiga River.*

The cities of Cebu and Mandaue have been facing a natural disaster which is flooding for decades due to several factors including human actions of improper waste disposal and direct runoffs from the environment. It can be seen in Figure 2 of the observed condition of Mahiga River as the result of human activities where trash or plastics accumulate in different areas most especially near the bridge which could be a factor that would impede the flow of water and increase the risk of overflowing and flooding. Because of improper disposal and human activities, the water quality has been adversely affected and it is not suitable for the use of daily lives of residents like drinking or to be used for washing clothes.

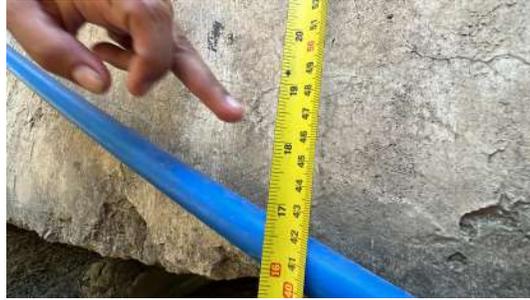
**Figure 3.1.** *Measuring of Maximum Flood Height.*

The maximum flood height may reach above the river embankment which is due to the blocked flow of water due to the accumulation of trash in the river. Its maximum height reached approximately 18 inches above the river embankment.

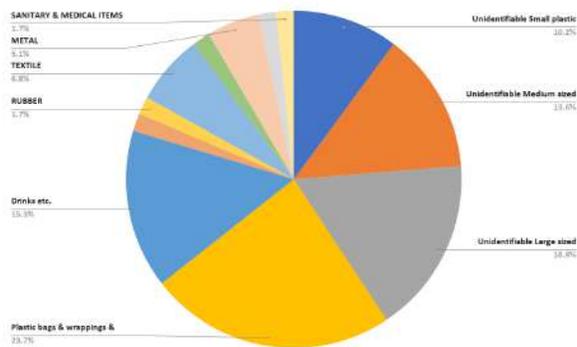
**Figure 3.2.** Riverbanks.

Figures 2.2 and 2.3 showcase the estimation of plastic pollution in the riverbanks and floating through the midstream Mahiga river. Experimentation for plastic waste was conducted by generating a quadrant of 1 square meter (1 m<sup>2</sup>) and randomizing different points in the accessible riverbanks and areas of the river. Overall with numerous classifications of plastic wastes, Figure 2.3 reveals that in the elevated riverbank of midstream Mahiga, unidentifiable medium plastic constitutes to most of the plastic wastes while the least is from plastic bags and wrappers. In contrast to the data collected in the riverbanks, the category on plastic bags and wrappers greatly contributed to the plastic wastes floating in the river. Based on the results of the tests, the floating plastic pieces per 1 m<sup>2</sup> is 48 plastics belonging to slightly polluted while the plastic pieces per 100 m riverbank is 243 plastics belonging to the polluted category. The data on plastic pollution is an essential data in knowing the river's water quality and flood-prone risks which is valuable in identifying viable solutions and measures to mitigate the current issues experienced in the area.

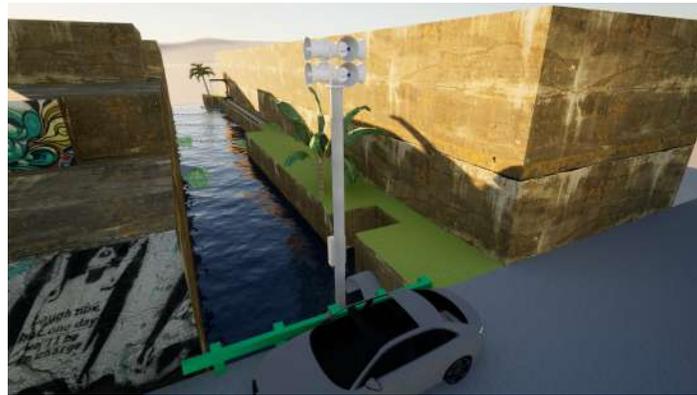
**Figure B.6.** Existing System at Subangdaku Bridge

Taking into consideration that the river comprises varying depths, it is most preferable to install the AFS into the portion of the river that is not shallow. Moreover, existing catchnets in the Mahiga are installed near the bridge and the lack of maintenance results in the accumulation of trash from the whole stretch of the midstream portion of that particular area in the river. With our solution, we plan to install the AFS in the area from the upper portion of the midstream stretch towards the bridge (*see Figures B.4. & B.5.*).
