Rotterdam University
of Applied Sciences

University of San Carlos, Talamban, Cebu City, Philippines
Rotterdam University of Applied Sciences, Rotterdam, The Netherlands

**“METRO CEBU RIVER SCAN CHALLENGE 2023”
RESEARCH REPORT AND INNOVATIVE SOLUTION PROPOSAL**

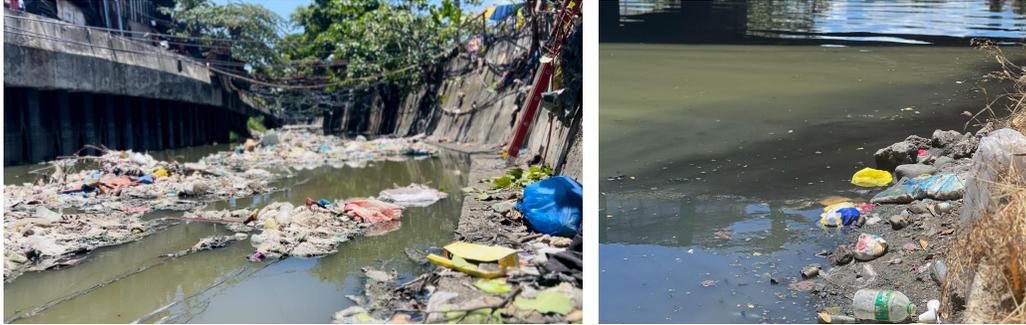
Mahiga River near SM Mabolo (left) and Hypermarket (right)

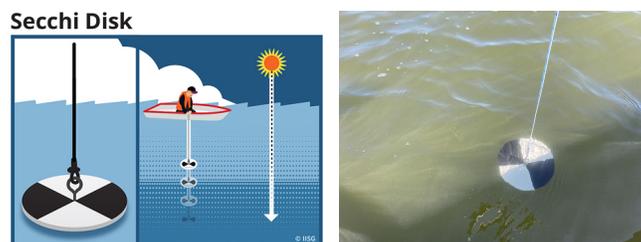
Visual representation and actual secchi disk

Turbidity. The river's level of murkiness is gauged by its turbidity. Turbidity rises as a result of any clouding of the water (Government of Northwest Territories, n.d.). A ***Secchi disk*** was utilized to identify the river's turbidity. A line is coupled to a Secchi disk, which has quadrants that alternate between black and white. In order to gauge the water's turbidity, the line coupled to the disk is used to drop the disk into the body of water. The measurement is made at the depth at which the disk is no longer visible (Limno Loan, n.d.).

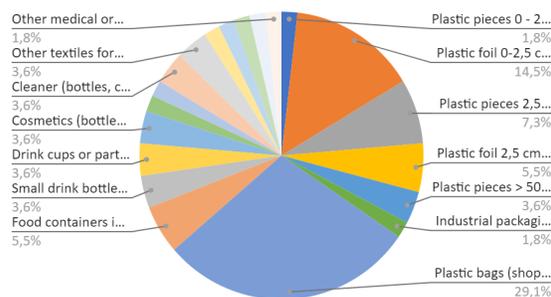
Categories of Riverine Waste

Based on the left pie chart which is the classification of riverine plastic waste, the type that has the highest percentage is the plastic bags garnering 29.1% of the total riverine plastic waste while other medical or sanitary items, plastic items less than 2.5 cm, and industrial packaging and plastic sheeting have the lowest percentage, 1.8%. On the other hand, the right pie chart about the percent composition of the categories of riverine waste shows that plastics have the highest percentage of 87.3%. It can be inferred that most of the riverine waste comes from the domestic or residential sector. This has been evidently seen during the ocular inspections done on the river site where various types of used plastics can be found floating.

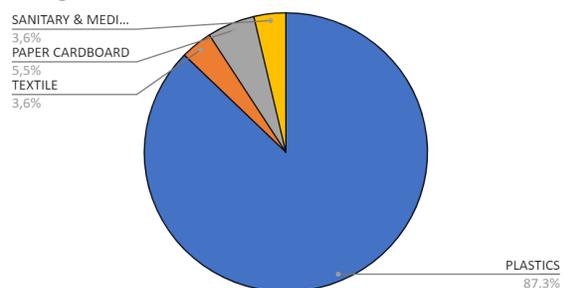
Riverine Litter Composition along the Mahiga River

The findings are then cross-referenced with the plastic waste category index. It can be found out that there were 550 pieces per 100-m riverbank which falls under the category of Class D having a remark of being severely polluted.

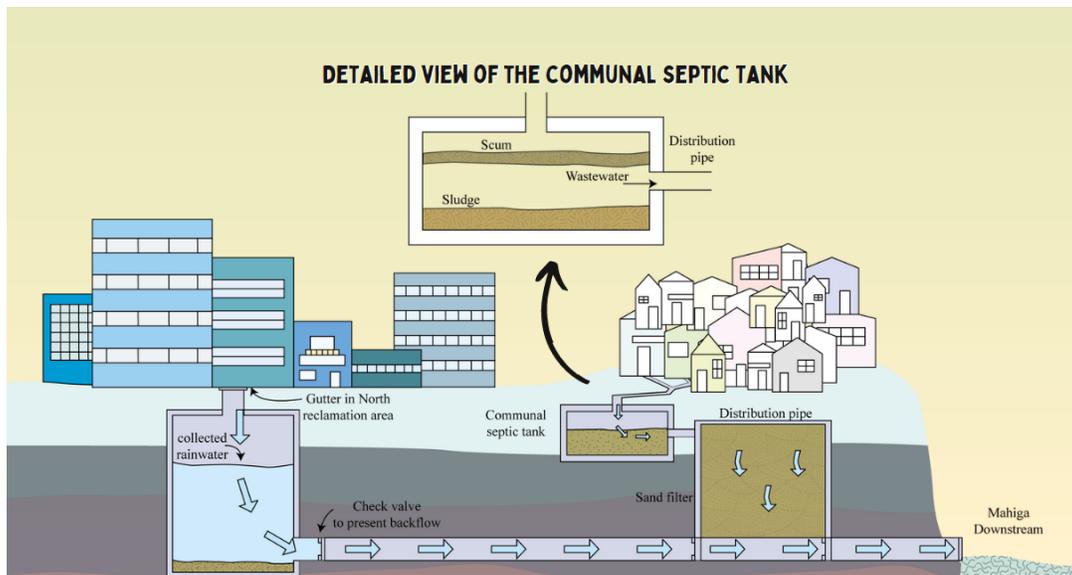
- ❖ ***1st Phase: Catch Basin and Check Valve.*** The 1st phase of the solution is the strategic installation of catch basins below the existing manholes or gutters per block of the North Reclamation Area. These catch basins are installed in a manner that does not disrupt the flow in the existing pipe system below the North Reclamation Area.

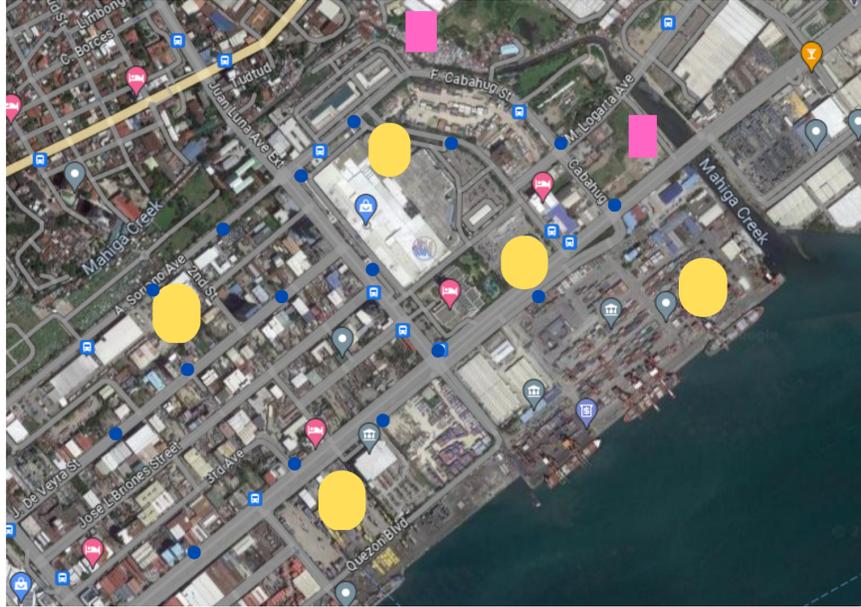
Map of the North Reclamation Area

As seen on the image above, each yellow square symbol in the map symbolizes the Catch Basin. The pink rectangle symbol is where the group will make communal septic tanks wherein residents' waste will go through a filtration device that involves minerals that filter the water, allowing clean water to flow through the connected pipes from the catch basin from north Reclamation area. The blue dotted symbols are manholes within the area that will serve as the waypoint of stormwater to enter the Catch Basin.

The “**C2K System**” is an underground system that catches stormwater in order to avoid flooding within the North Reclamation Area and helps utilize Mahiga River to its full potential. A catch basin, also known as a storm drain inlet or curb inlet, is a structure used to collect rainwater and other surface runoff from streets, parking lots, and other paved surfaces. It is typically a large, open box-like structure with a grate or filter on the top to prevent large debris from entering the basin. The catch basin will help in delaying and storing rainwater as the stored water can be used in other ways such as vegetation. With the existing one way pipe system straight to the river, each area within 50 meters below will be installed with Catch Basins.
