## Assignment 2: Maximum Flood Heights

Group 10

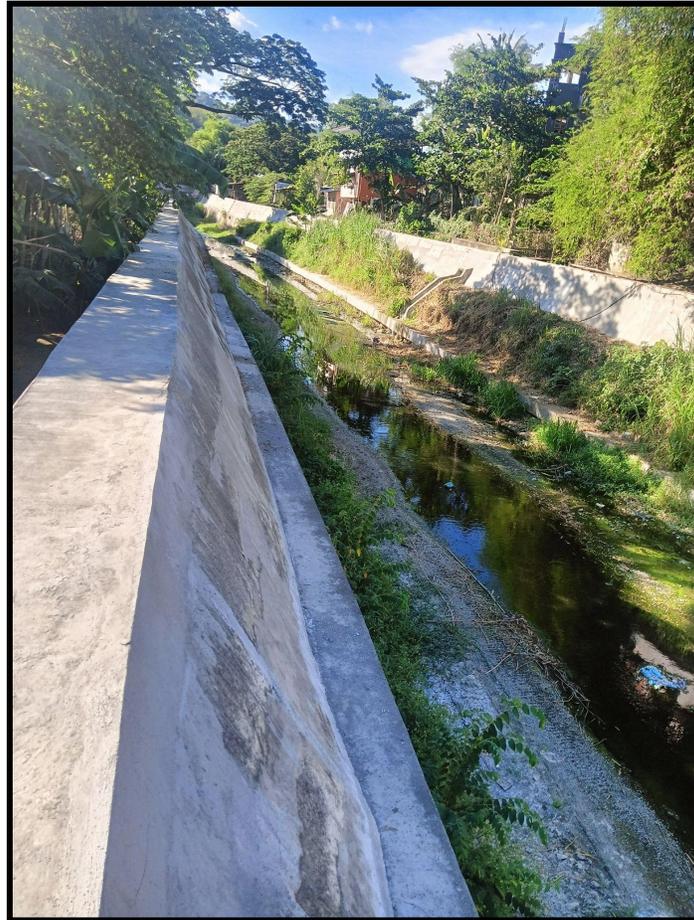
**Barangay San Jose** is a riverside community that has long struggled with flooding, especially during heavy rains. According to residents, a retaining wall was built earlier this year to help prevent severe flooding in the area. The structure now stands as a protective barrier between the river and nearby homes.

*The River in Barangay San Jose*

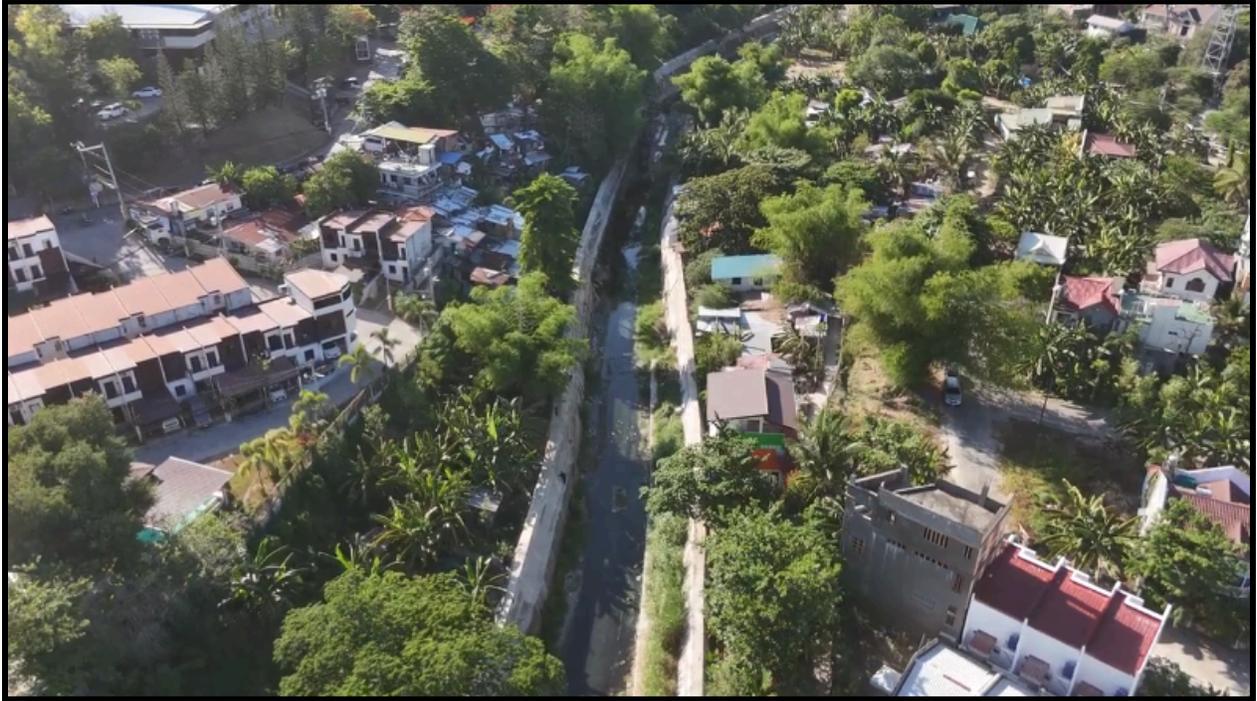
Flooding has been a long-standing problem for many households in Barangay San Jose. Residents shared that before the newly built retaining wall was constructed, floodwaters from the river could reach as high as the second floor of their homes. The new wall has significantly reduced this risk, bringing a sense of relief and safety to the community.

*Some of the Houses Near the River*

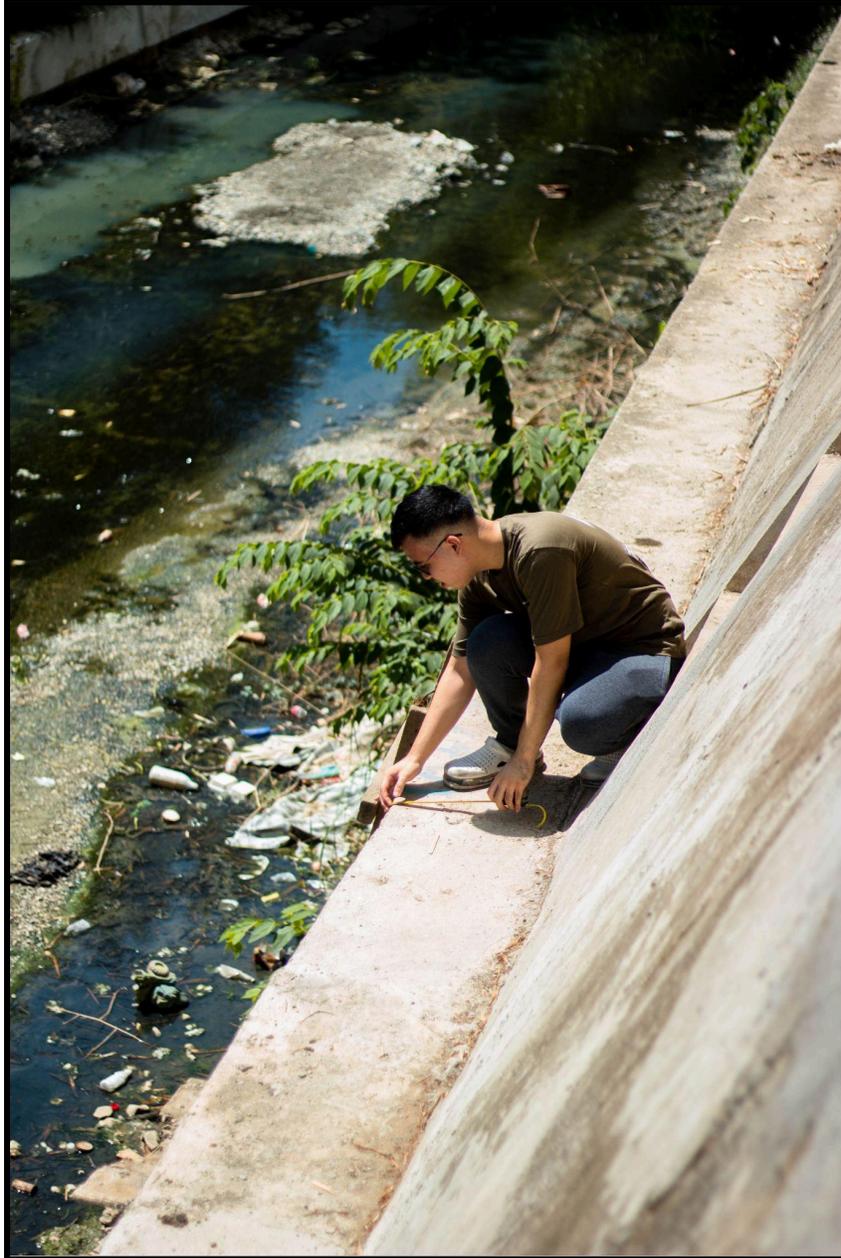
The height of the **original retaining wall** was measured at **2.89 meters** using a tape measure. The **newly built wall on top** adds an **additional 2.31 meters**, bringing the total height from the bottom of the river to the top of the new wall to **5.2 meters**.

*Measuring the Height of the Walls*

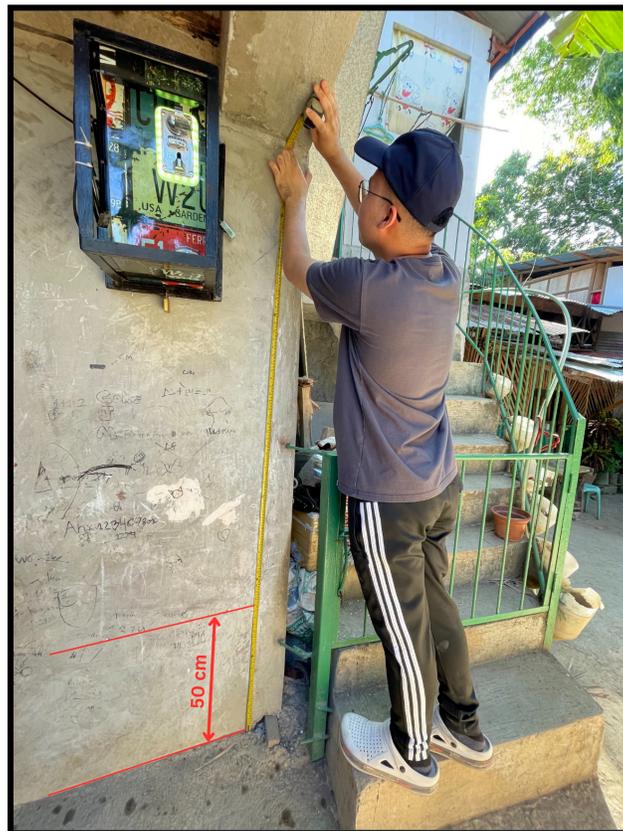
According to residents, they have not experienced any catastrophic flooding since the construction of the new retaining wall. **Before the wall was built**, floodwaters could reach up to the second floor of their homes, **averaging about 4.48 meters above ground level**. When referenced from the base of the river (excluding the height of the newly built retaining wall), **the estimated maximum flood height was around 7.37 meters**.

**After the construction of the new wall**, the highest flood level recorded so far only reached **50 centimeters above ground level**. Referenced from the base of the river, **the estimated maximum flood height has dropped significantly to 3.39 meters**.

*Measuring the Maximum Flood Height*
