**CIVN4005: Investigational Project**

**Capability of Permeable Pavement Systems in Johannesburg**

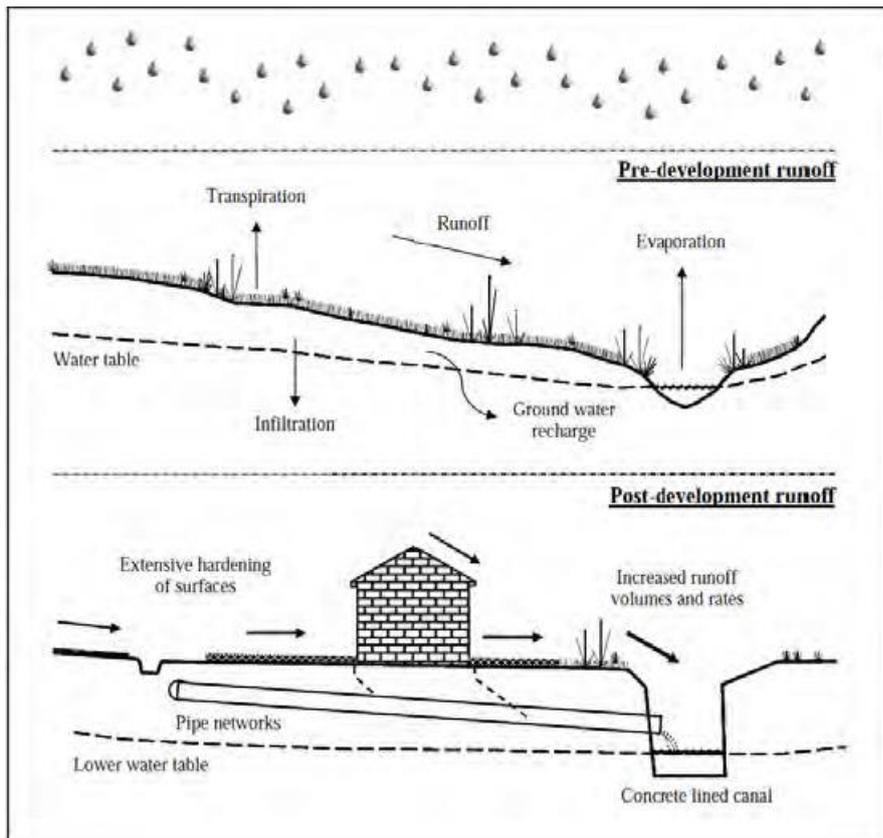
Figure 2-1: Typical pre- and post-development scenarios with the conventional approach to stormwater management (Armitage, et al., 2013)

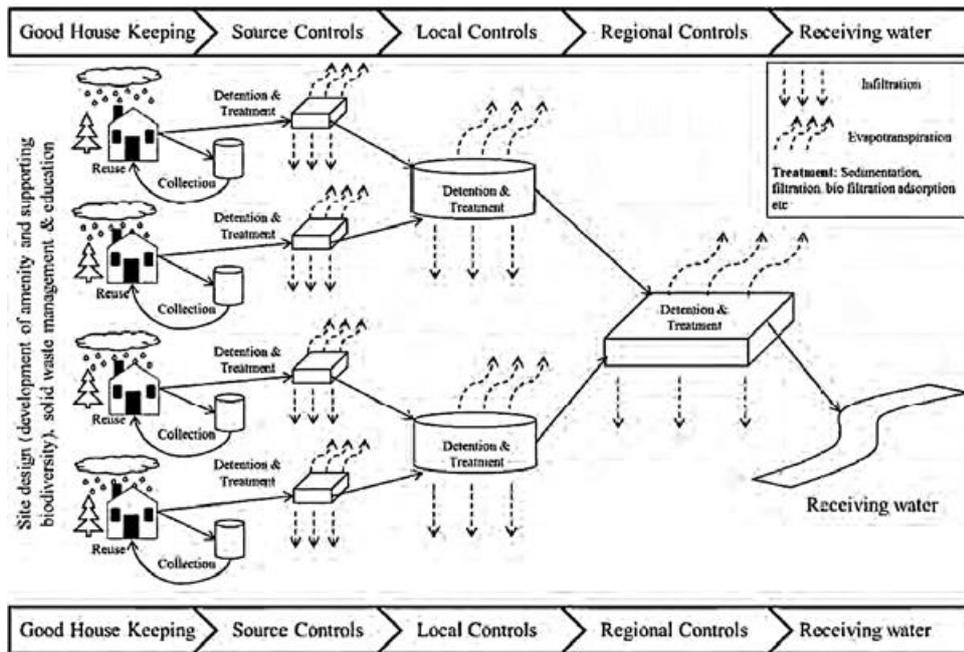
Figure 2-2: Treatment Train Schematic (Armitage, et al., 2013)

The effectiveness of SUDS, specifically regarding stormwater management and the removal of pollutants, is dependent on a so-called treatment train, or series of unit processes (Armitage, et al., 2013b; Armitage, et al., 2013; Wilson, et al., 2004). Each process has particular capabilities with respect to water quality treatment, attenuation and reduction of volumes and so a series of processes or trains are usually required to meet all the design criteria. Treatment train options may be combined in any order but have broadly been categorised into four categories: good housekeeping, source controls, local controls and regional controls, as seen in Figure 1-2.

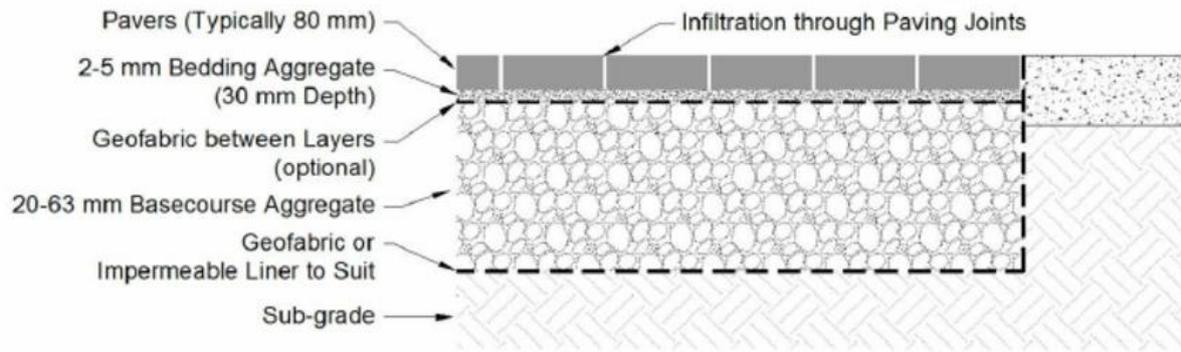
Figure 2-3: Standard Layout of a PPS (Lucke, et al., 2013)

PPS involve two types of structural elements: monolith (infiltration through the pavement surface only) and modular (infiltration through surface joints) (Lucke, et al., 2013). These structural elements (also considered load-bearing surface materials) include: 'porous pavement' (porous concrete/asphalt), brick or permeable concrete block pavers, gravel and even just grass (very low traffic loading) (Armitage, et al., 2013). These materials are built on a sub-base of coarse gravel (which allows infiltration into groundwater) (Armitage, et al., 2013).

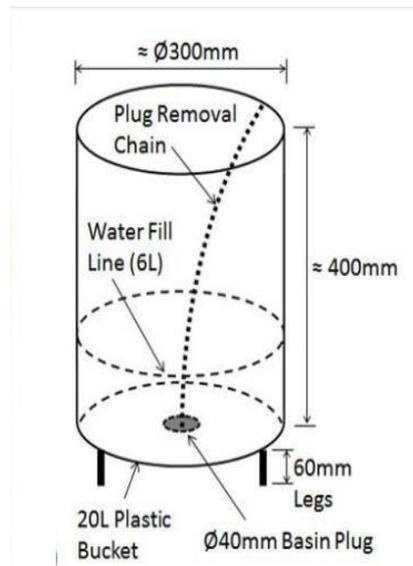
Figure 2-4: Stormwater Infiltration Field Test (SWIFT) Infiltrometer (Lucke et al., 2015)

A simpler infiltration test can be done: the stormwater infiltration field test (SWIFT) which makes use of a 20L bucket with a 4mm diameter hole in the centre of the bottom of the bucket. The hole is plugged, the bucket is filled with 6L of water and raised about 60mm. The plug is removed and the number of fully wetted bricks is counted to determine blockage (Bernard, 2019; Lucke, et al., 2015).

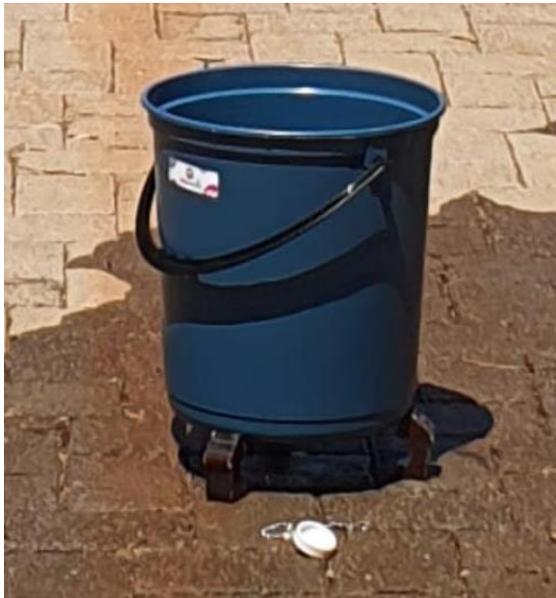
Figure 3-2 shows the apparatus used for all spot tests conducted. 6l of water was measured and marked clearly inside the bucket to ensure all tests were done with 6l of water. The bucket was raised 60mm and had a 40mm diameter hole at the bottom for the water to flow out once unplugged.

Figure 3-2: SWIFT apparatus used

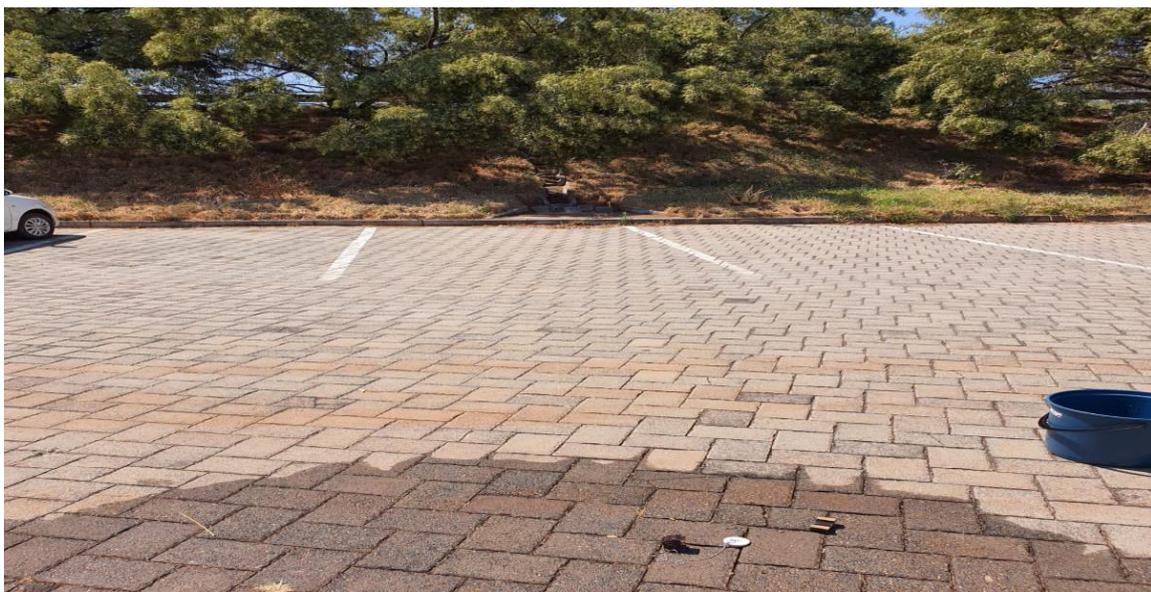
Figure 3-3: Wits Parking Paving Type – similar type used for both upper and lower parking lots.

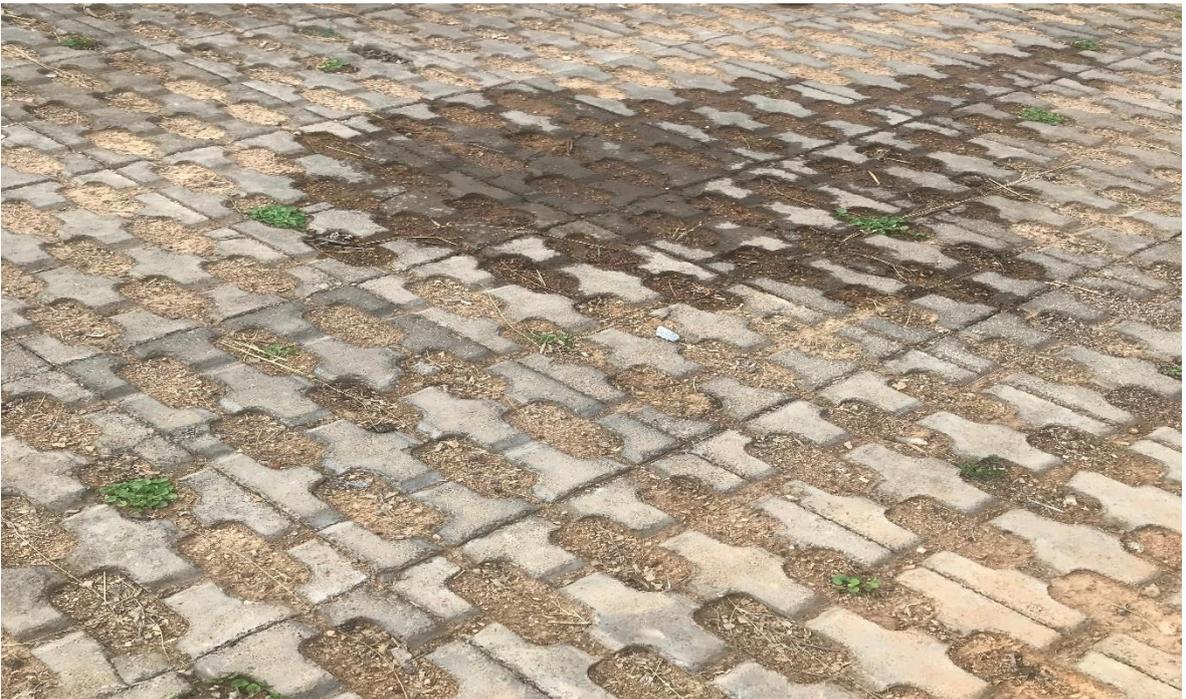
*Figure 3-5: Broadacres Academy Type 2*

The PPS in operation at Broadacres consists of open-block grass paving. Two types were observed and can be referred to in Section 3.3. Test sites 1-5 are type 1 and were installed midway through 2018 whilst test sites 6-9 are type 2 and were installed at the beginning of 2020. The PPS were located only at the parking bays whilst the surrounding access roads were of normal paving. The site had a gentle slope, sloping towards a drainage area marked “D” in Figure 4-5. The spot test sites are also shown in Figure 4-5 with the results shown in Table 4-5.

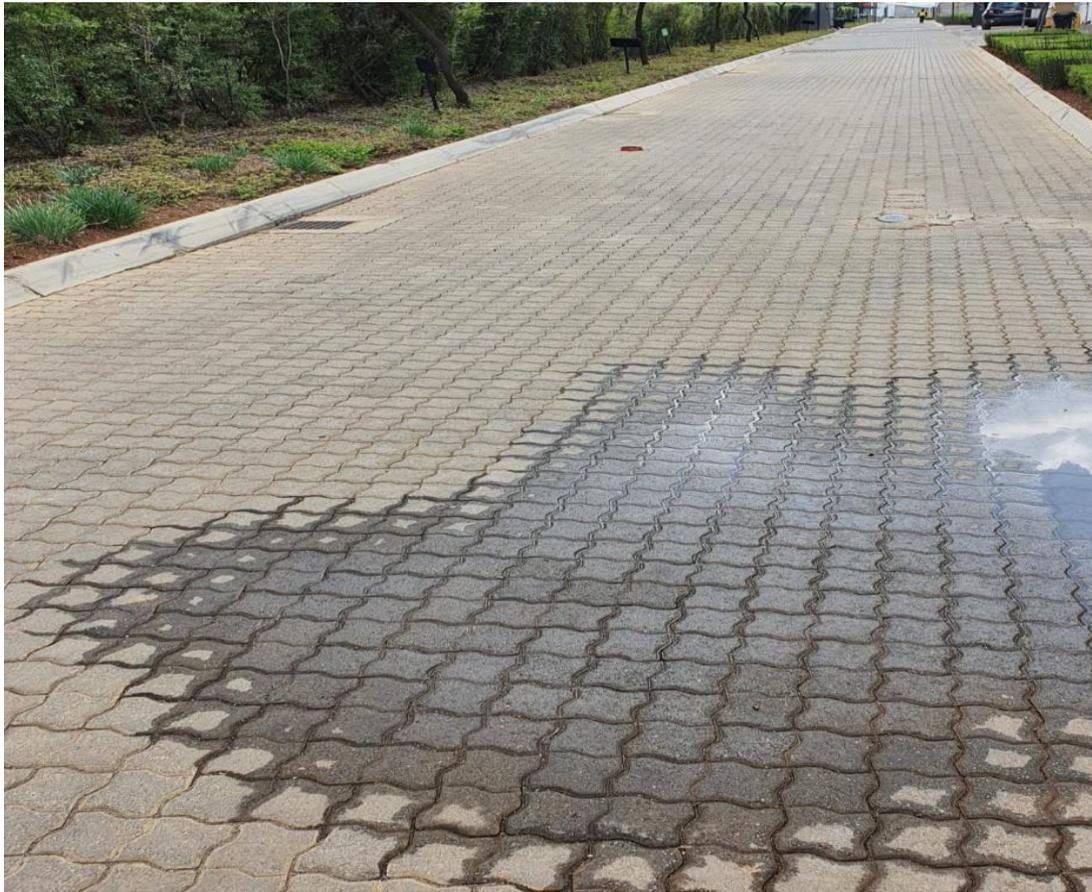
*Figure 3-6: Toyota Type 1 - also indicating slope towards multiple drainage points*

Tests 1-5 were of type 1. Tests 6 and 7 were of type 2 paving, resembling those found at the Wits sites, the nature of which is similar to that of type 1 with each paving having a larger surface area. Tests 8-10 were of type 3 paving (open-block). It can be seen from Figure 4.8 that the open-block paving outperforms the other types by a large margin, however, as was observed at Broadacres Academy, the SWIFT test may not prove the most accurate testing method for this type of paving due to its retentive nature. At spot test 5, the drainage point problem mentioned was observed and thus an overestimated value of infiltration is recorded due to the water flowing into the drain.

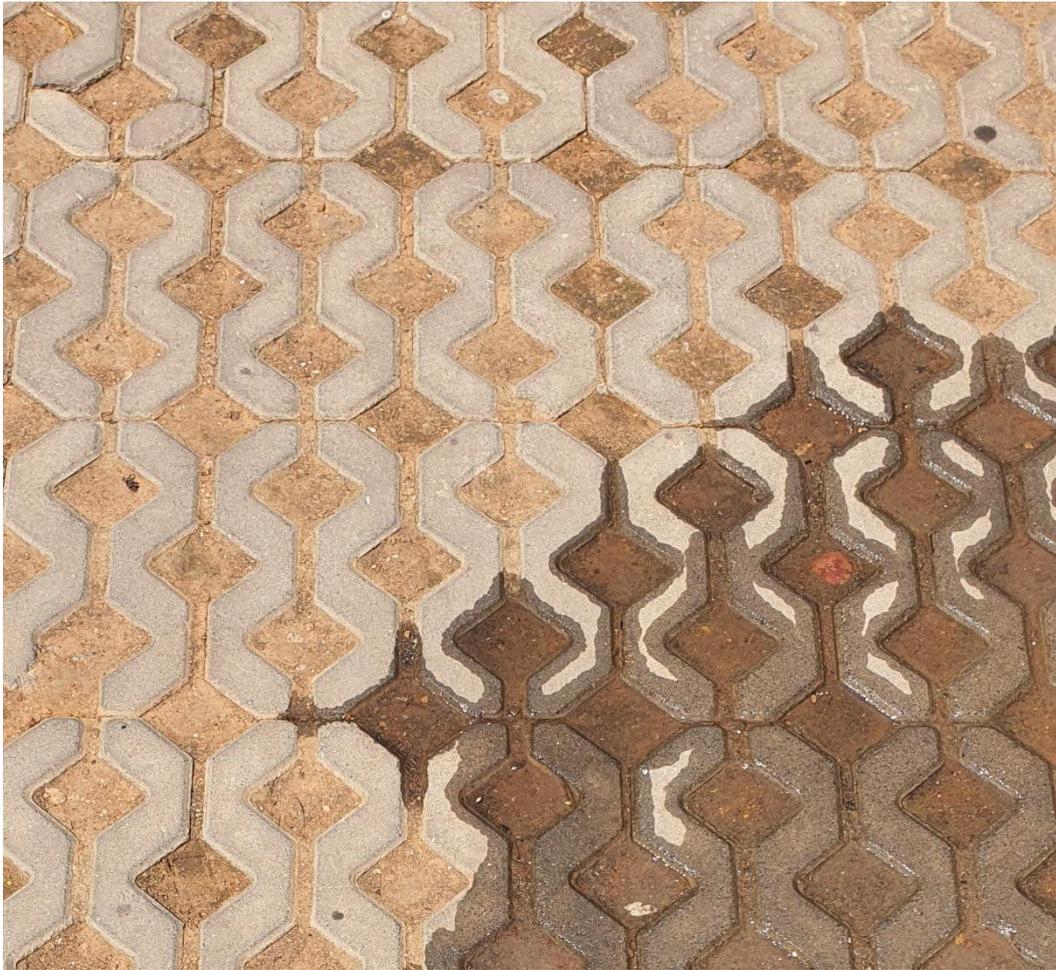
*Figure 3-8: Toyota Type 3*

It is evident upon noting the results from Broadacres Academy and Type 3 of the Toyota Centre that the open-block grass paving outperforms all other types substantially. This should be taken with caution as the SWIFT testing method may not be the most reliable method with regards to the open-block paving. Comparison of the open-block paving between both sites show that Broadacres Academy’s paving has an average infiltration rate higher than that of the Toyota Centre (2145mm/hr to 1322mm/hr). Later installation (2018 as opposed to 2013) could be a factor in this difference, as well as the traffic volumes each paving is subject to, as the Toyota Centre has high volumes of heavy trucks whereas the paving at Broadacres Academy is only subject to parked cars, thus less heavy traffic flow. It was also observed that the paving at Broadacres Academy had more vegetation growth in the individual block paving which once again can be attributed to the difference in traffic volume, and possibly also impacted the infiltration capacities.

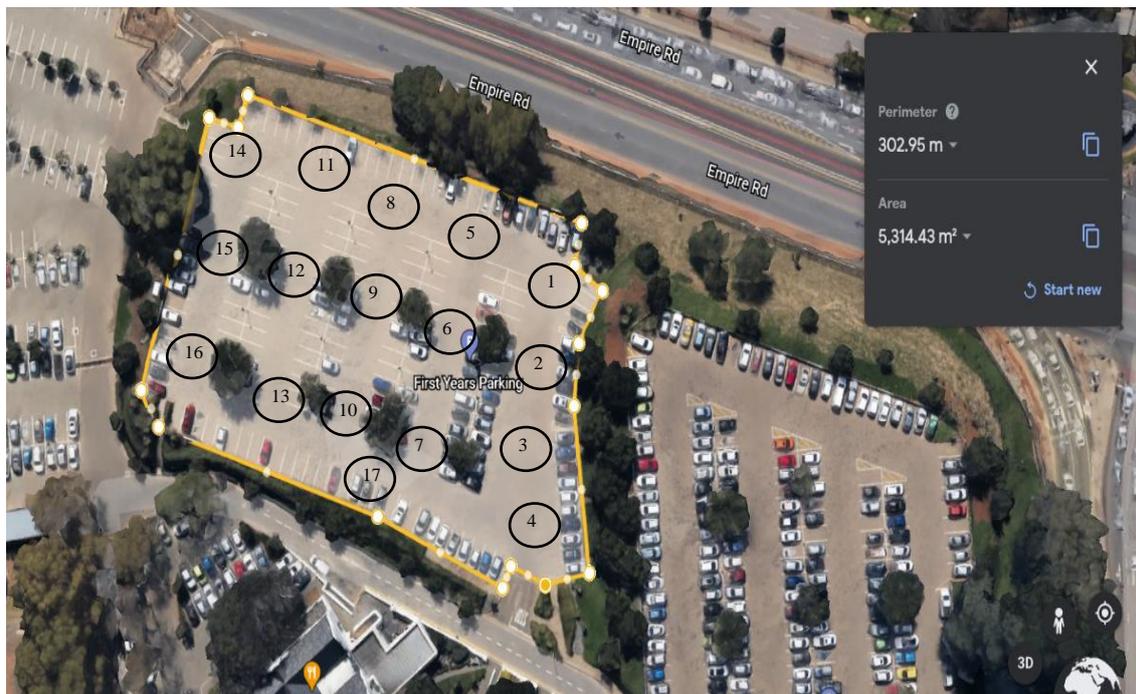
Figure 4-1: Wits Lower Parking test sites.

The University of the Witwatersrand's (Wits) permeable paving is found at two parking lots at the very northern end of the Braamfontein campus. The lower parking has been in operation since 2013 and has had no maintenance since instalment. The entire lot consists of PICP with scattered trees throughout. A small embankment marks the eastern border of the lot (above which the upper parking is situated) and can be seen in Figure 3-3. Tests were performed at the main driving lanes of the parking as this was deemed to have most traffic and thus would provide a more accurate representation of the deterioration of the PICP throughout its use. The location of these spot tests is shown in Figure 4-1 and the results can be seen in Table 4-1.

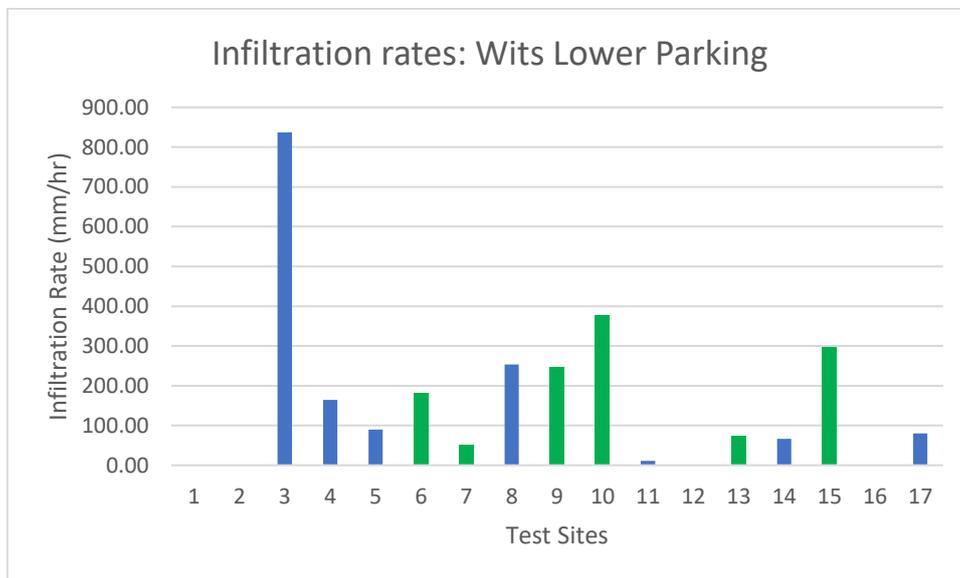
Figure 4-2: Wits Lower Parking Test Results

One of the factors investigated at this specific site, was that of a blocking wave. This is due to the assumption that the embankment present would aid in the transportation of sediments onto the paving and thus it was investigated as to whether the paving's infiltration capacity gradually worsened as it approached the embankment. Test sites 1-4, closest to the embankment, show no evidence of this being a true assumption when compared with other test sites. However, there are many factors that could have influenced the results such as the lack of maintenance and presence of vegetation throughout the site as can be seen in Appendix A. Thus, it is difficult to accurately analyse for any such patterns given the state of the system.

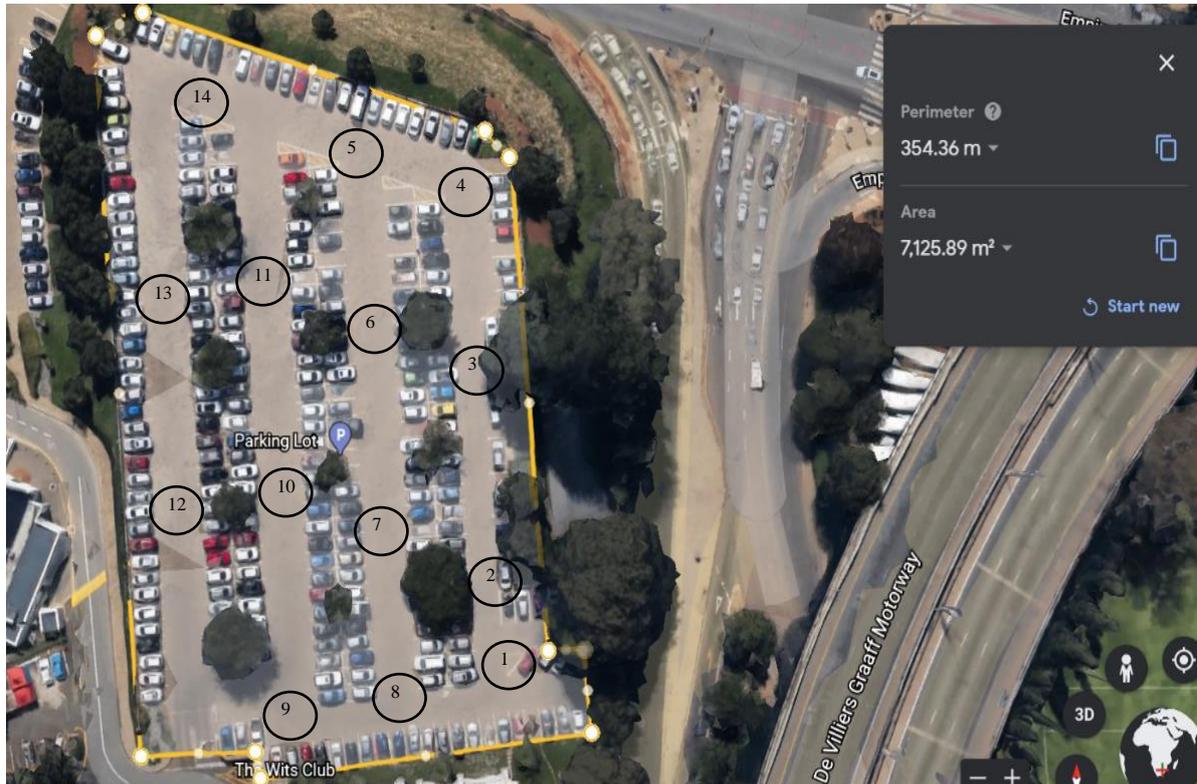
Figure 4-3: Wits Upper Parking test sites

The upper parking has also been in operation since 2013 but has had maintenance in the form of replacement in 2017. It has a similar layout to the lower parking in the sense that the entire lot consists of PICP with scattered trees throughout. Tests were performed at the main driving lanes of the parking for the same reason as previously mentioned. The location of these spot tests is shown in Figure 4-3 and the results can be seen in Table 4-3.

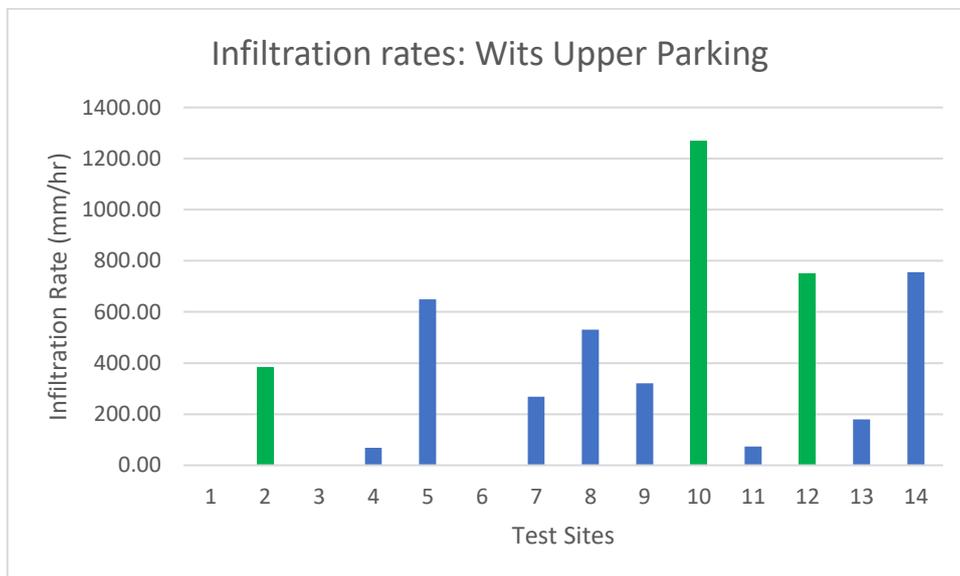
Figure 4-4: Wits Upper Parking Test Results

No blocking wave phenomenon was investigated due to the absence of any boundary controls. The presence of trees was once more investigated and the tests occurring within the vicinity of trees are filled in green in Figure 4-4 (Test Site 6 displaying a value of 0 also being one of these tests). Once again it can be seen that no visible pattern emerges, and the presence of trees cannot be taken to have a direct noticeable impact on the capability of permeable paving nearby. Poor maintenance was also observed in the form of major blockage as a result of fallen foliage and vegetation as can be seen in Appendix A.

Comparing the average infiltration rate obtained for both lower and upper parking lots, the upper parking lot performs better with an average infiltration rate double that of the lower parking. This can possibly be attributed to the fact that the upper parking had maintenance conducted in its lifetime, unlike the lower parking.

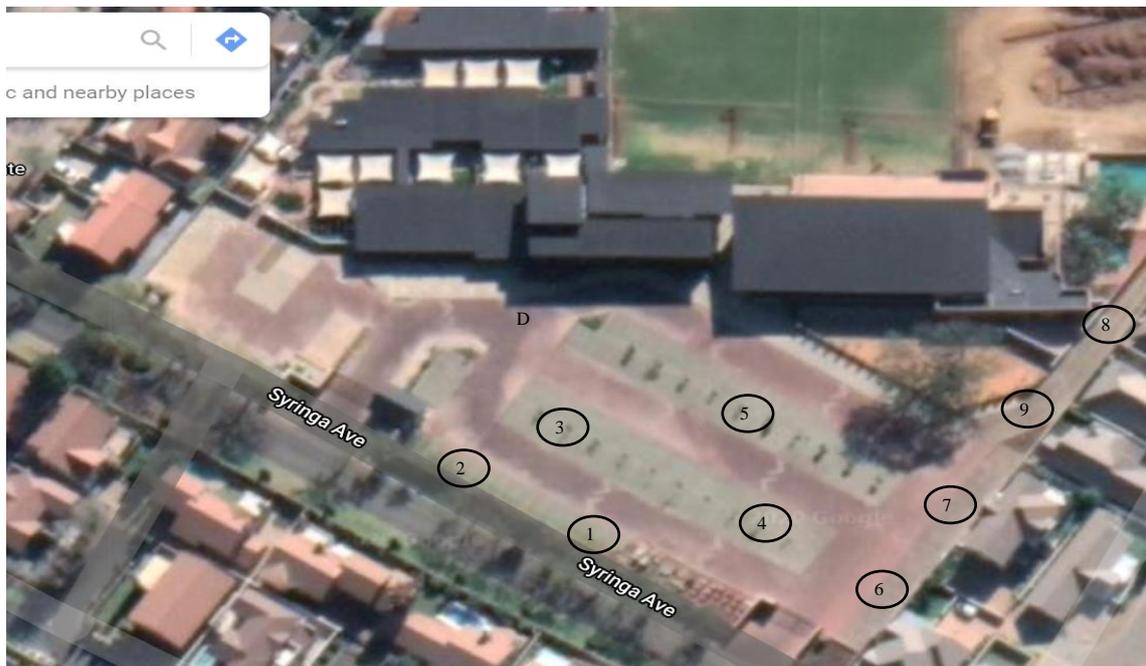
Figure 4-5: Broadacres test sites.

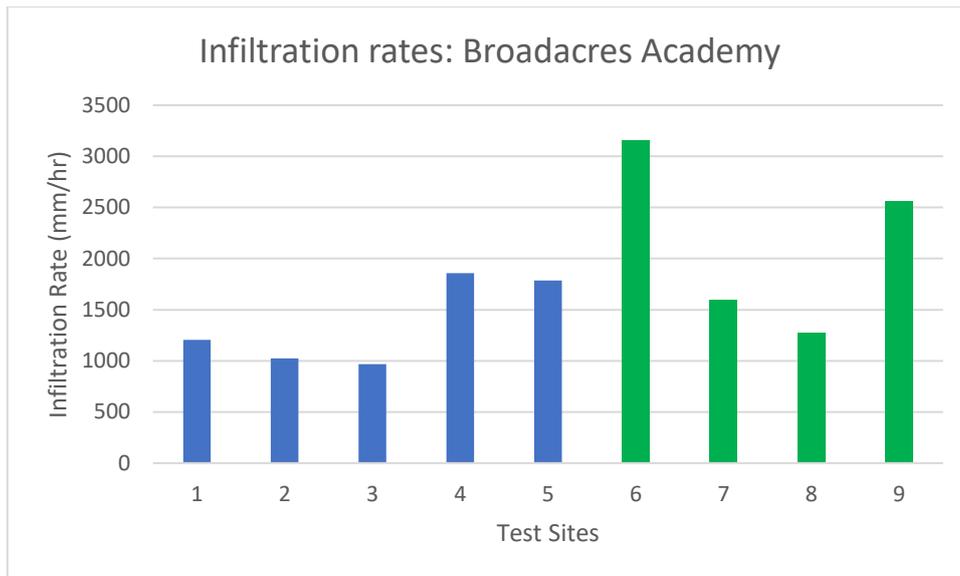
Figure 4-6: Broadacres Academy Test Results

The site was fairly uniform throughout with the only differences being that of the slightly different paving used as mentioned and therefore nothing in particular in terms of physical factors, was investigated. Those installed in 2020 (Type 2) are filled in green on Figure 4-6 and had an average infiltration rate of 2145mm/hr compared to the 2018 installations (Type 1) of 1368mm/hr. It can be estimated that the paving’s capability has therefore deteriorated by 32% over one and a half years.

A potential limitation using the SWIFT testing method for this type of PICP was identified as it was noted that in some instances the water would collect in pools within the open blocks of the paving. Thus, using the wetted area may have resulted in testing the paving’s retention capabilities as opposed to its permeable capabilities.

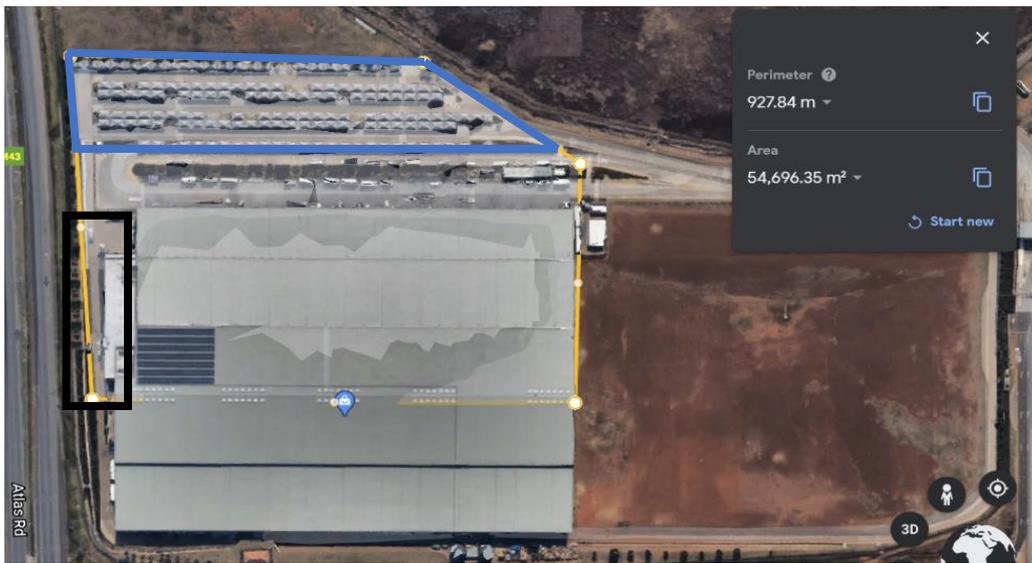
Figure 4-7: Toyota Site. Black outline indicates the PICP tested. Blue outline indicates PICP not tested.

The PICP found at Toyota consisted of three types which can be seen upon referring to Section 3.3. All three types were constructed in 2013 with no record of maintenance. Figure 4-7 depicts the entire site and Figure 4-8 (section marked in black on Figure 4-7) displays the three types in use that were made accessible, with types 1 and 2 (shown in orange and yellow respectively) being of a standard type of PICP and type 3 (shown in green) an open-block grass paving similar to those found at Broadacres Academy. The lower orange section (Figure 4-8) was sloped towards the left towards multiple drainage points (shown in Figure 3-6), and thus potentially having an effect on the testing as the water would flow immediately towards the drainage points, as the roadway was not very wide, resulting in some tests losing accuracy as the wetted area was restricted due to the exit point being provided. Therefore, some of the tests may have resulted in a higher infiltration rate due to its low wetted area being reported. The test results are shown in Table 4-7.

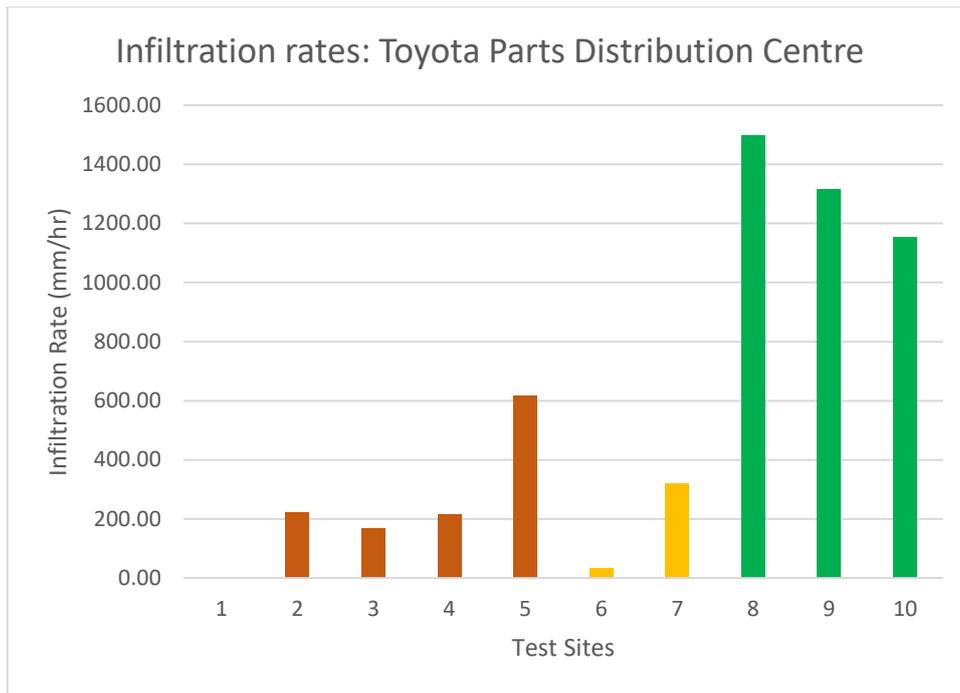
Figure 4-9: Toyota Parts Distribution Centre Test Results

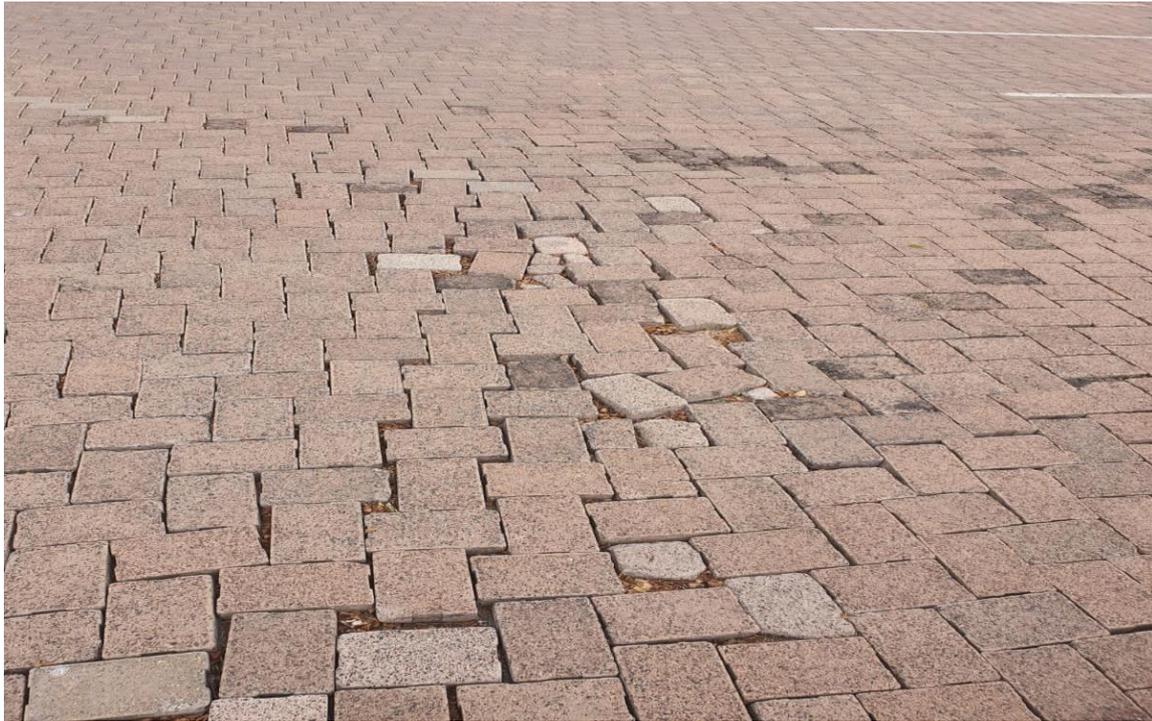
*Figure A-3: Wits Upper Parking indicating poor construction/maintenance resulting in failure of the PPS.*

However, it should be noted that the maintenance construction of the upper parking paving is poor as can be seen in Appendix A, with major gaps between poor placements of paving. These gaps may contribute to an increased infiltration rate as water will flow more readily than if placed adequately and thus may not accurately reflect the infiltration capabilities of the pavement itself.

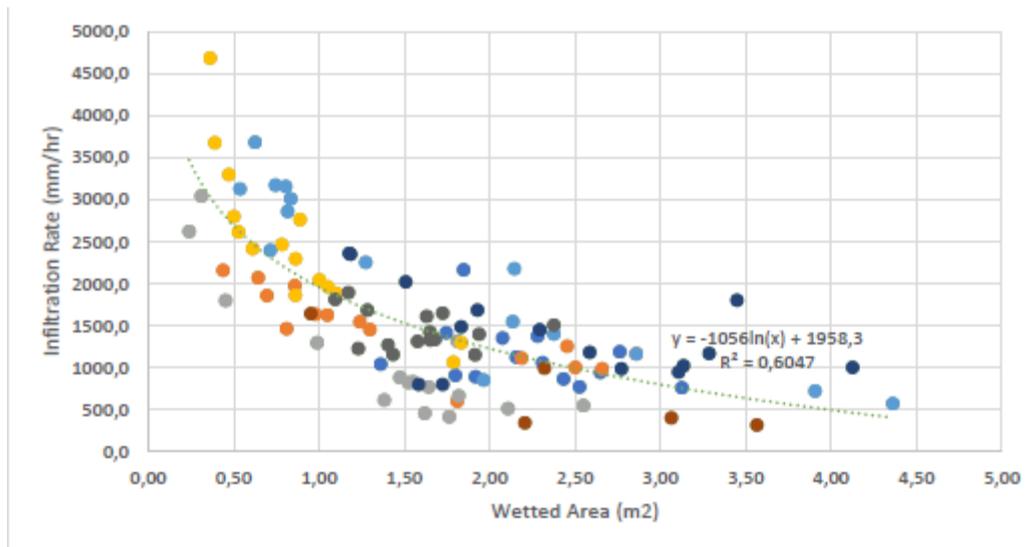
Figure B-1: Logarithmic correlation between infiltration rate to wetted area (Bernard, 2019)

Figure B-1 shows the correlation between the single ring infiltration test (as outlined in ASTM) and the SWIFT test. The infiltration rate is obtained using the single ring infiltration test and the wetted area is obtained using the SWIFT test. The two are then plotted and a correlation factor of  $R^2$  is found. A logarithmic relationship was chosen as it showed the highest correlation between the two test types.

The infiltration capacity of the PPS for each site was then determined by using the equation presented in Barnard (2019) found by correlating results from the ASTM Standard test and the modified SWIFT test. The graph giving this correlation can be found in Appendix B.
